Investigation Report

ExxonMobil Torrance Refinery Electrostatic Precipitator Explosion Torrance, California

Incident Date: February 18, 2015

No. 2015-02-I-CA

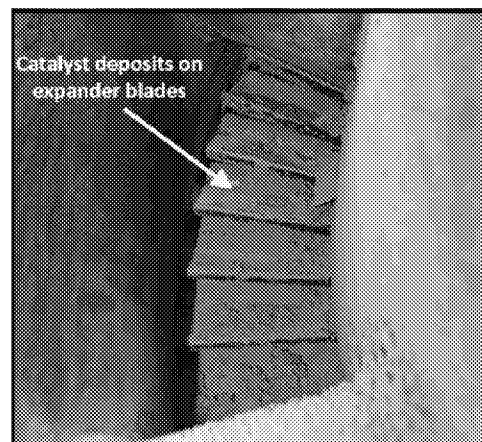
FIGURE 10

The gas that flows through the expander contains a small amount of catalyst particles that may, over time, build up on the expander blades (Figure 10). Uneven distribution of this buildup causes the expander to vibrate excessively, which can cause significant damage to the expander. Torrance refinery instrumentation monitored the vibration of the expander so that when the expander vibration increased to a certain level, operators could clean the catalyst buildup from the expander blades.

Catalyst buildup within expander. Photo was taken post-incident in 2015.

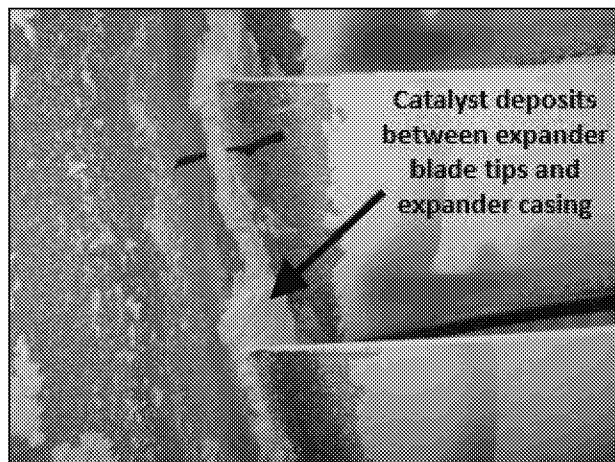
FIGURE 14

ExxonMobil personnel predicted the expander could not restart due to catalyst buildup between the expander blades and casing. Photo taken following expander outage in 2012.

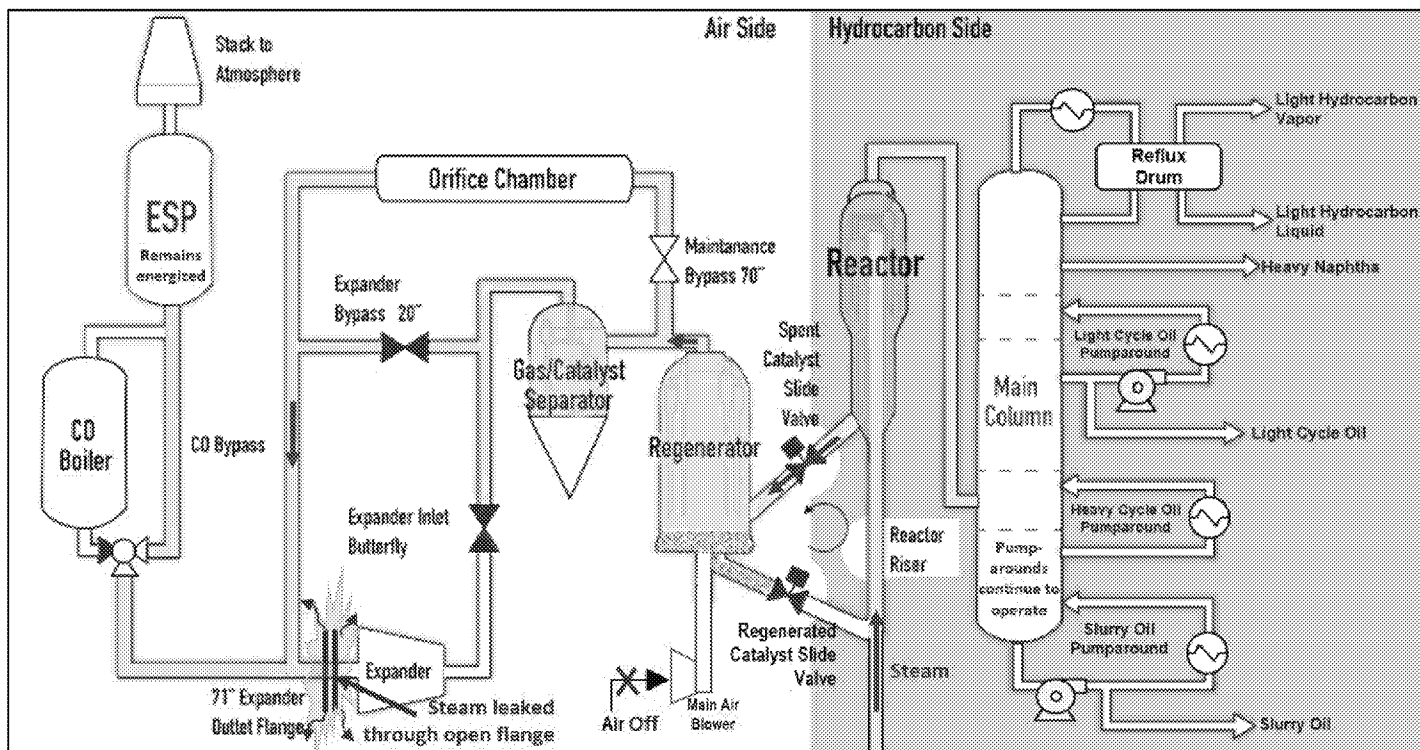
FIGURE 15

On the morning of the incident, steam leaked out of the open expander outlet flange. Steam from the reactor had leaked through the eroded SCSV, through the FCC unit air side piping and equipment, and out of the open flange.

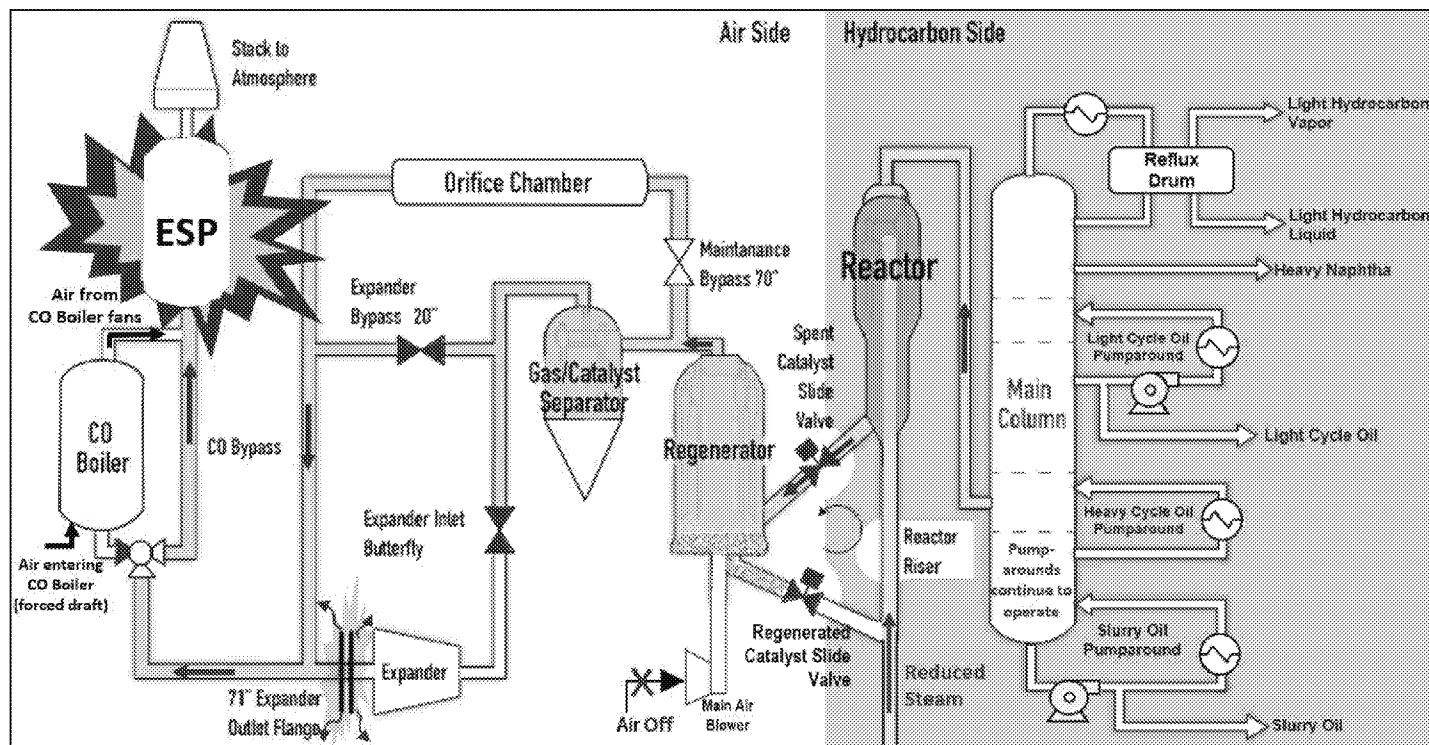
FIGURE 17

When steam flow rate was reduced through the reactor riser, reactor pressure could no longer prevent hydrocarbon backflow from the main column. Hydrocarbons leaked through closed SCSV, through FCC unit air side piping and equipment, and to the energized ESP. A hydrocarbon/air mixture ignited inside of the ESP.

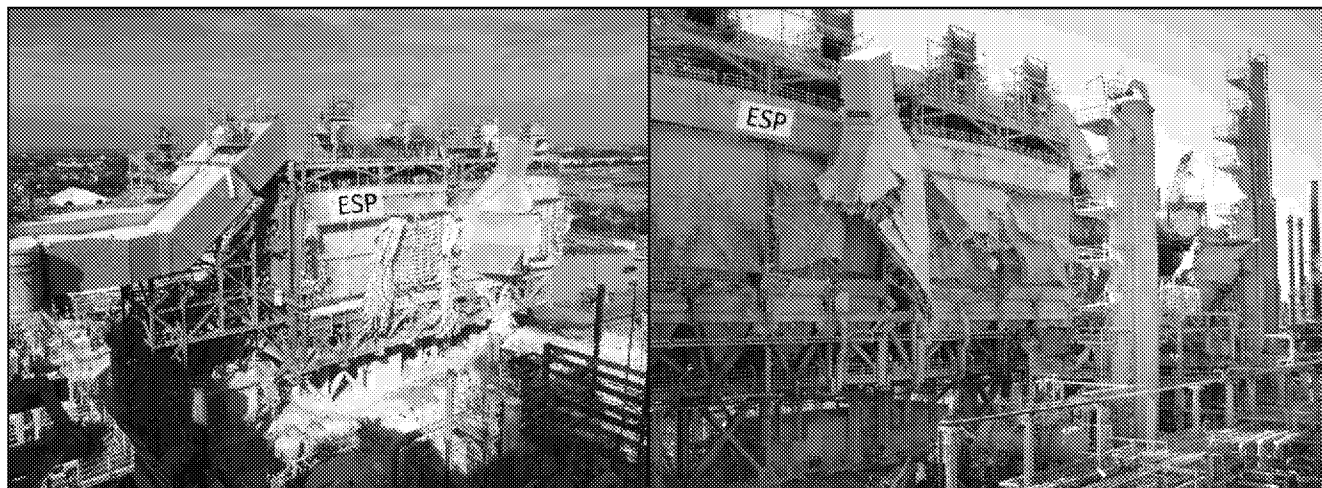
FIGURE 18

The explosion severely damaged the ESP (Figure 18). Debris from the explosion hit equipment near the ESP, causing two small fires and multiple leaks of flammable liquids. The explosion debris also punctured a heat exchanger that was out-of-service. Four contract employees who were working nearby sought first aid for injuries sustained while fleeing the area. Debris also fell on a building frequently used by operators, though was unoccupied at the time. In addition, catalyst dust was reported outside of the refinery property in the nearby community.^{36,37}

Damage to the ESP from the explosion. White catalyst dust from the ESP is visible on the ground in left photo.

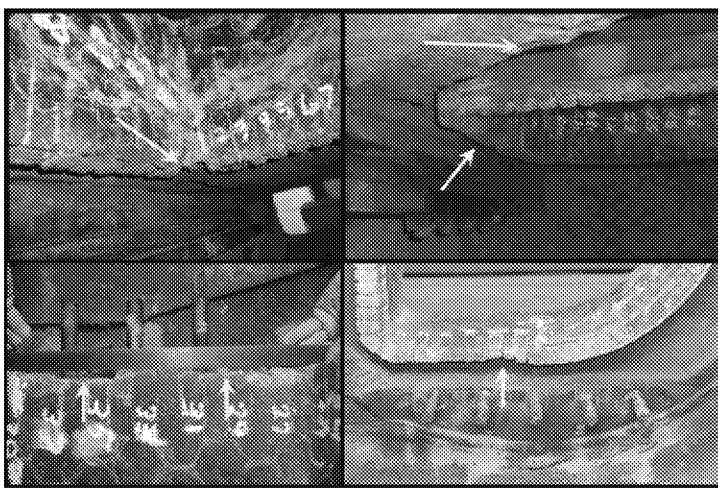
FIGURE 23
SCSV erosion identified post-incident

Following the February 18, 2015 incident, the CSB inspected the internal components of the SCSV. The inspection found the valve internals to be severely eroded to the point that the valve could not seal. An area of approximately 16 square inches eroded away during six years of operation, providing an open path for catalyst to flow through the valve even when in the fully closed position. The erosion prevented the closed SCSV from developing the necessary catalyst barrier on the day of the incident. Photos of the erosion identified in the SCSV are shown in Figure 23.

The SCSV operates in a severely erosive service. The continuous flow of abrasive fluidized catalyst particles during normal operation erodes the slide valve internals, which can prevent the valve disc from sealing. ExxonMobil repaired the SCSV internals during turnarounds in 2000, 2004, and 2009 because the valve had eroded. An ExxonMobil “Equipment Degradation Document” details the likelihood of SCSV inability to seal due to erosion of the valve (Figure 24).

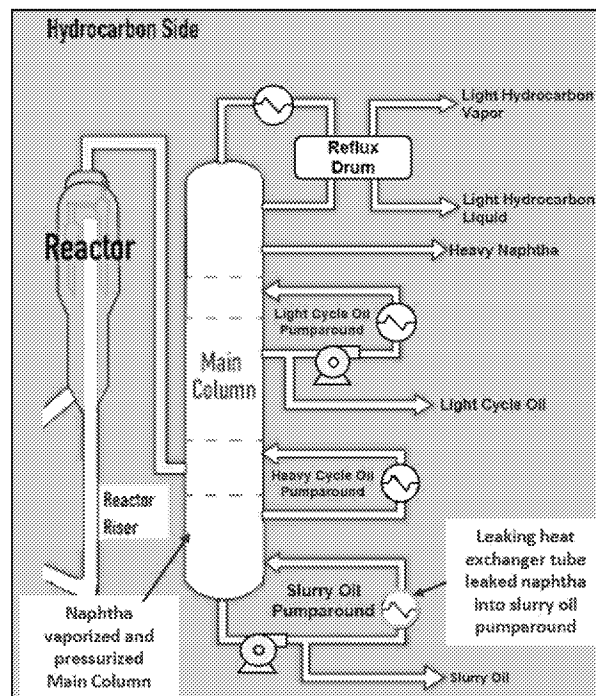
FIGURE 28

Leaking heat exchanger tube allowed light naphtha to enter main column.

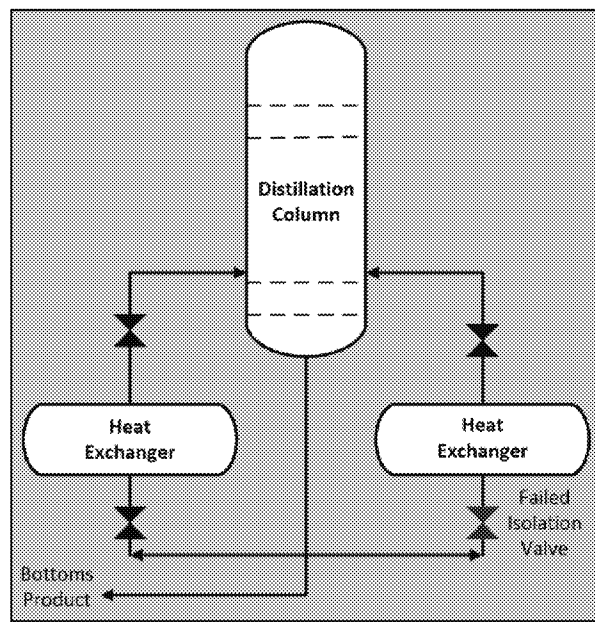
FIGURE 30
Heat exchanger shell-side path showing isolation block valve that would not close

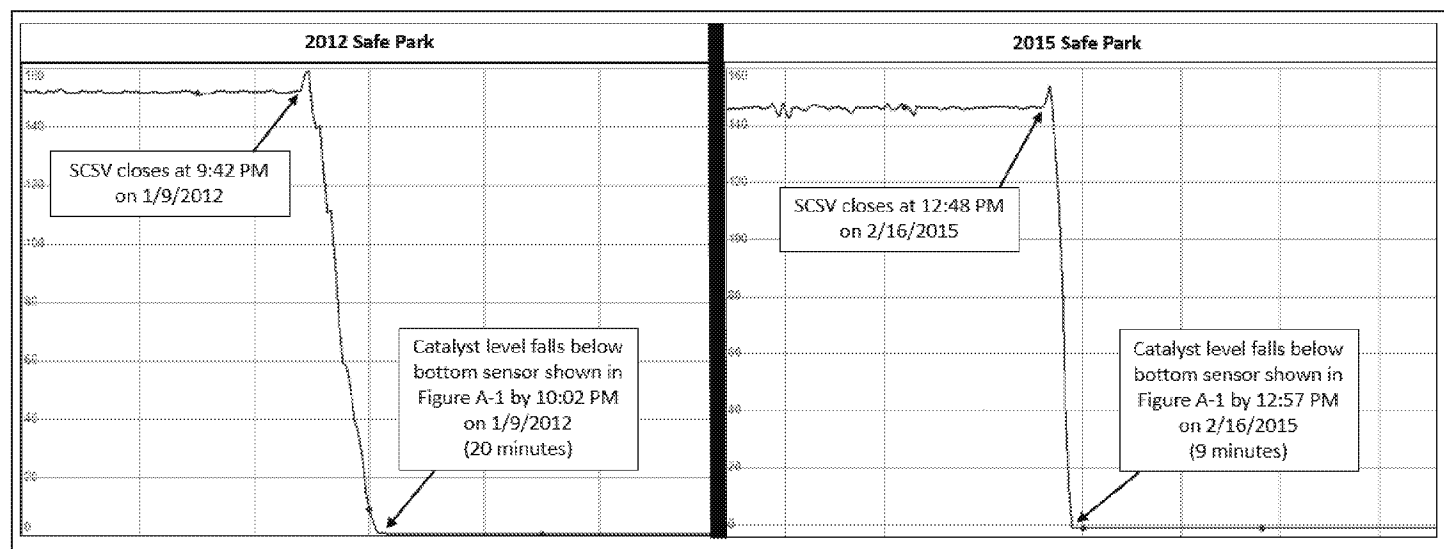
FIGURE A-2
In both 2012 and 2015, catalyst leaked past closed SCSV when unit entered Safe Park. In 2012, catalyst level fell below level sensors shown in Figure A-1 in 20 minutes. In 2015, catalyst level fell below level sensors shown in Figure A-1 in 9 minutes.

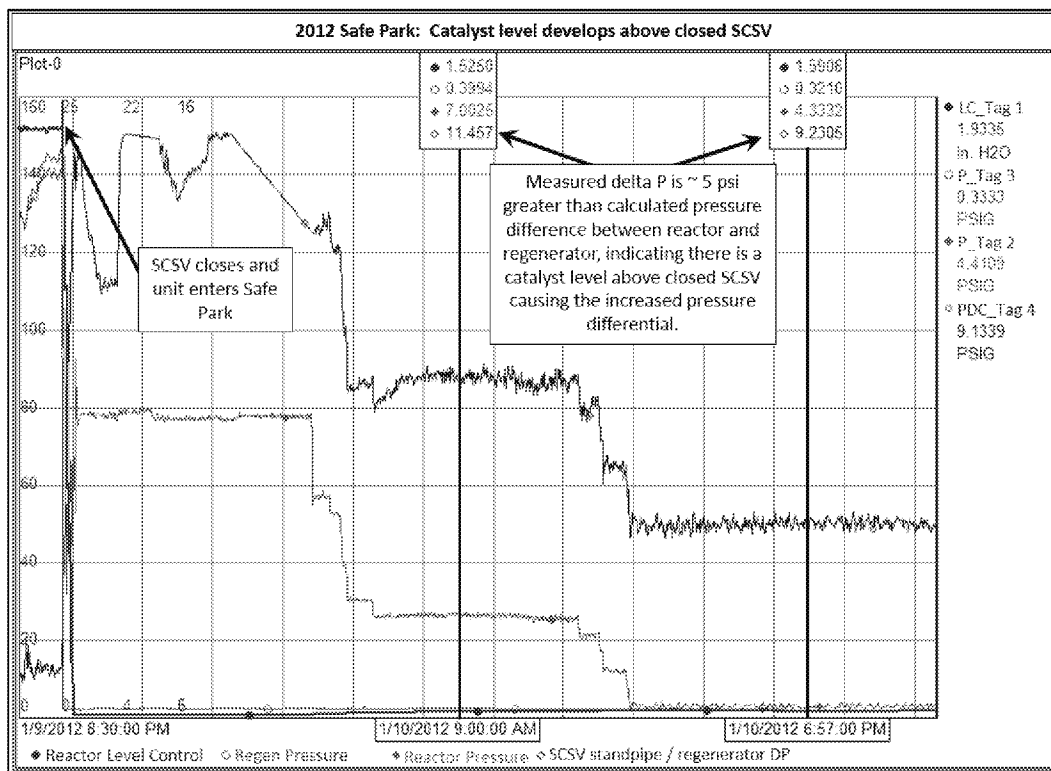
FIGURE A-4

In 2012, measured SCSV standpipe/regenerator differential pressure exceeded calculated reactor/regenerator differential pressure, indicating that catalyst had accumulated above the closed SCSV.
